# Starry Stonewort in Big Turtle Lake

Nicole Kovar, MNDNR NW R1 Invasive Species Specialist

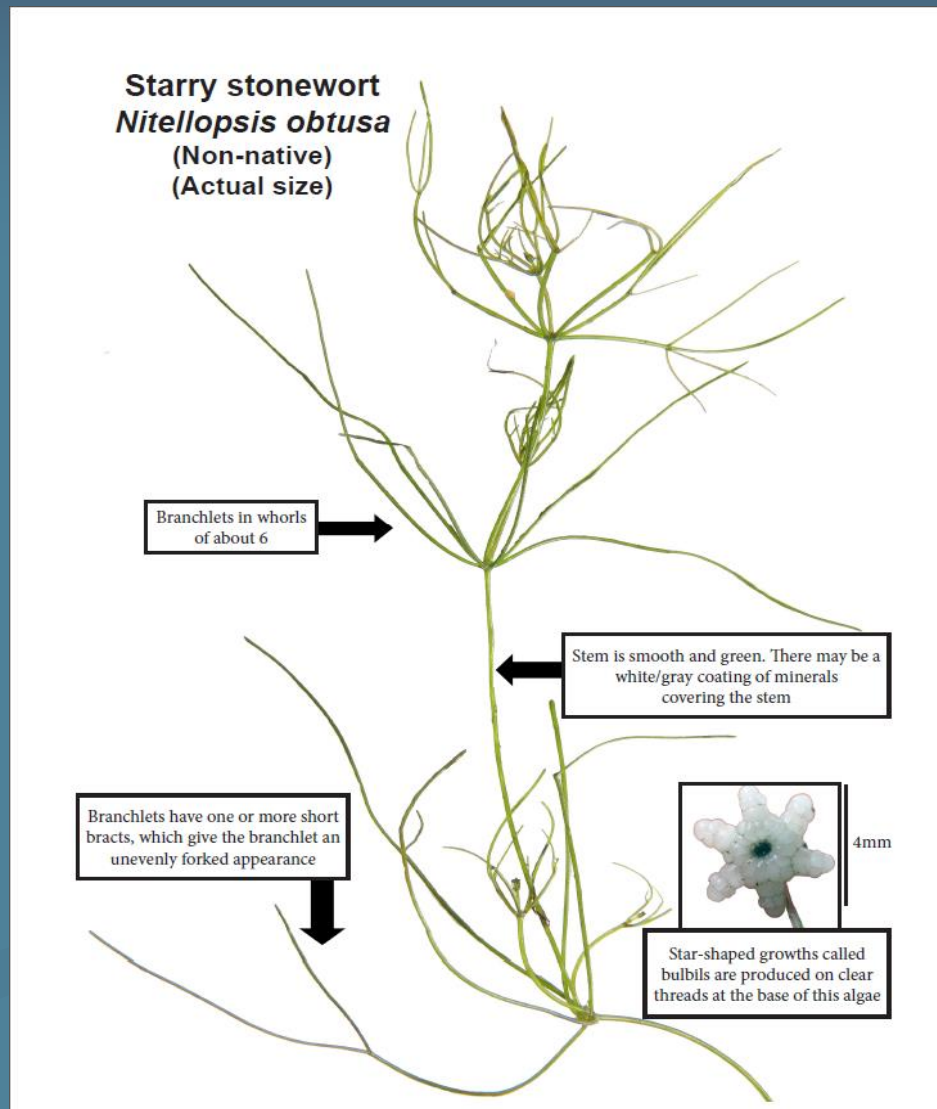
- Branchlets of 5-8 whorls, each with 1-2 long bract cells
- Appearance of the branchlet being forked
- White, star-shaped bulbils

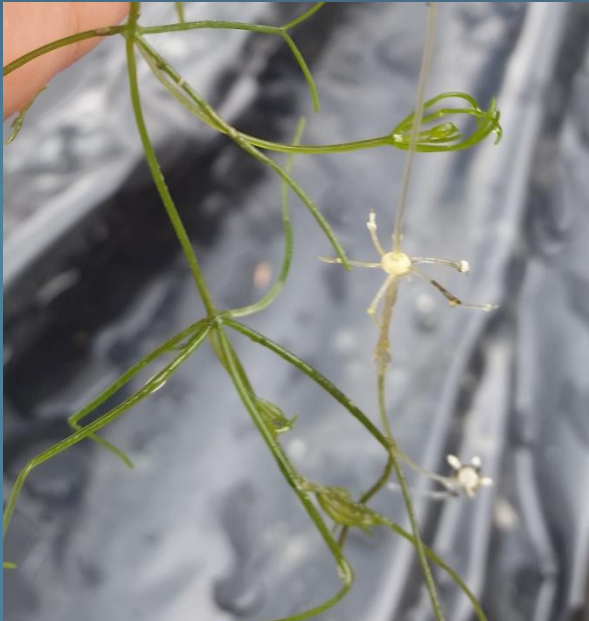
### Means of Spread:

- Unintentional transfer of bulbils and/or fragments

### Impacts:

- Dense mats, at water surface
- Interfere with recreational activities
- May displace native vegetation
- Potential to impact fishing habitat

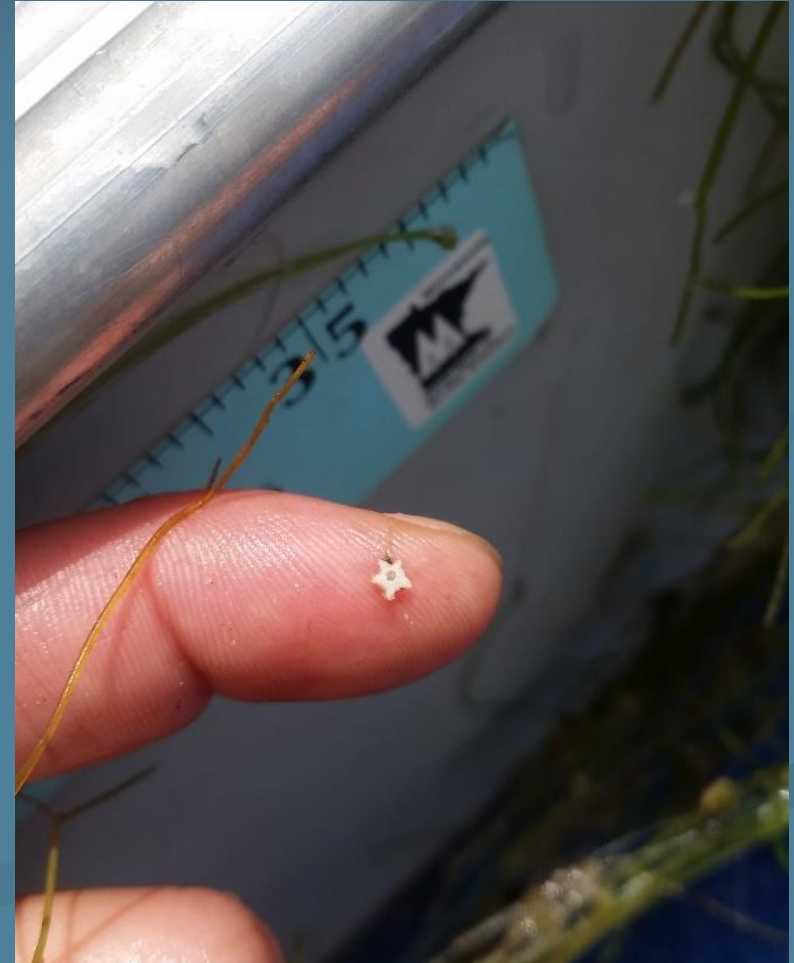
- Initial discovery of SSW by Beltrami County staff and reported to MN DNR
- Verification received by Dr. Ken Karol of the New York Botanical Garden same day
- 185 miles away from the first known SSW infestation in Minnesota
- Importance of Early Detection Programs

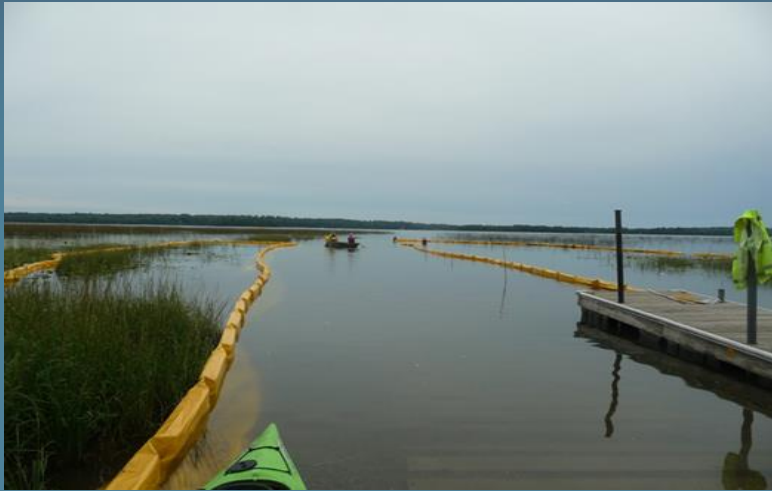
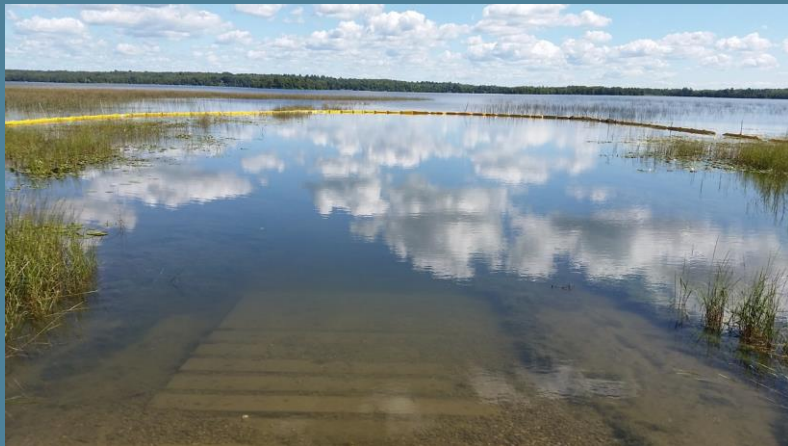
# Response cont.

- Access closure was discussed, options pursued
- Aug 18<sup>th</sup>-Containment barriers first installed around the bulk of the biomass
  - More extensive survey of the area to determine boundary
- Aug 25<sup>th</sup>-Boating lane and dock removed
- Aug 26<sup>th</sup>-0.75 acre treatment plot enclosed
- Aug 26<sup>th</sup>-Access officially closed after temporary lease signed with Kohl's Resort

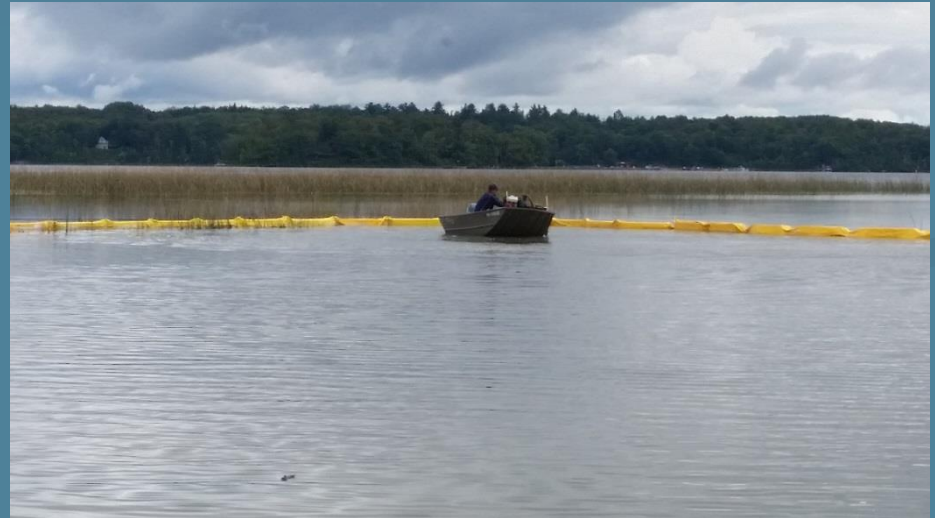
# Treatment Plan Cu Application

- Sep 5<sup>th</sup>-Suction harvesting completed  
Equipment experienced mechanical difficulties
- Equipment decontaminated before leaving site
- Sep 6<sup>th</sup>-Copper sulfate applied by PLM
- Sep 9<sup>th</sup>-Silt curtain removed and access reopened

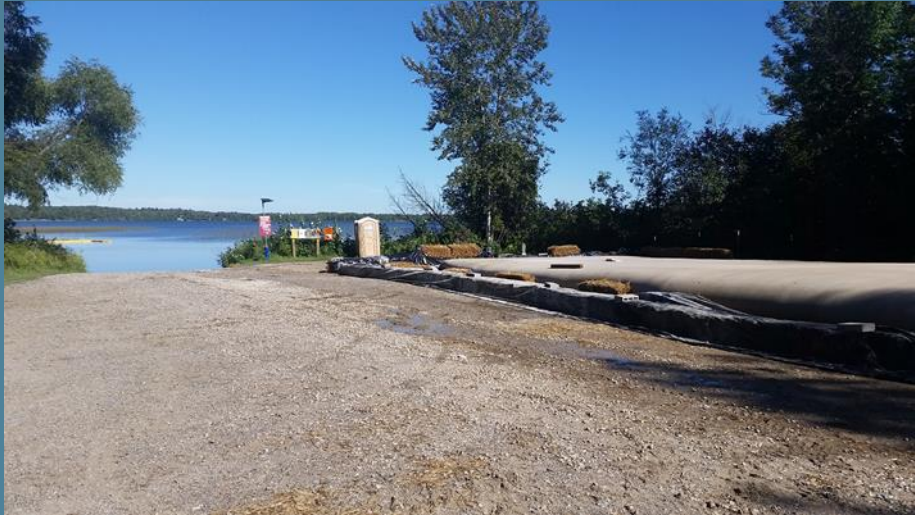
# Post treatment actions

- Disposal site at inactive Beltrami Co. gravel pit
- Sep 27<sup>th</sup>-Dewatering bag and contents hauled to the disposal site
- 405 estimated tons of sediment and plant matter removed
- Silt curtains moved to off-site location for decontamination
